Improving on an Old Veneer Case: A CASE REPORT

TIMOTHY C. ADAMS, DDS, LVI M

The following case report focuses on the improvement of a 12 year old veneer case. The patient presented to the author with the desire to improve on her existing veneers and to solve the problem of a veneer continually coming off.

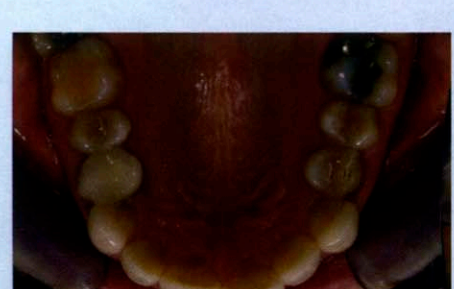
FIGURE 4

A 37 year old female presented the desire to improve the aesthetics of her existing veneers (figures 1,2,3,4,5). The patient was in excellent health and was periodontally stable. She had no other restorative needs except for a lower molar that required a small direct resin. We discussed the musculoskeletal signs and symptoms form and palpated her muscles (some of which were sore), but her desire was to only address the aesthetics of her maxillary arch. We addressed realistic expectations about shape, color, teeth and the challenges associated with tetracycline stained teeth.

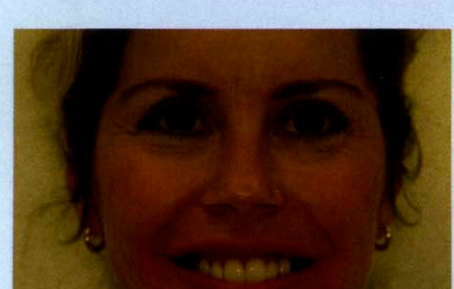
FIGURE 5

This allows the lab the room to be able to create the ideal width/length and golden proportion ratios. One of the problems with the initial veneers was that there was not enough tooth reduction coupled with the lack of interproximal space to set the ideal golden proportions due to the fact that the teeth were not sliced prepped. This caused a bulky look to the veneers and a less than ideal arch form (figures 5). In our quest
