## RESTORATION OF AN ENDODONTICALLY TREATED TOOTH UTILIZING A SINGLE-UNIT CROWN AND CORE SYSTEM

Timothy Adams, DDS

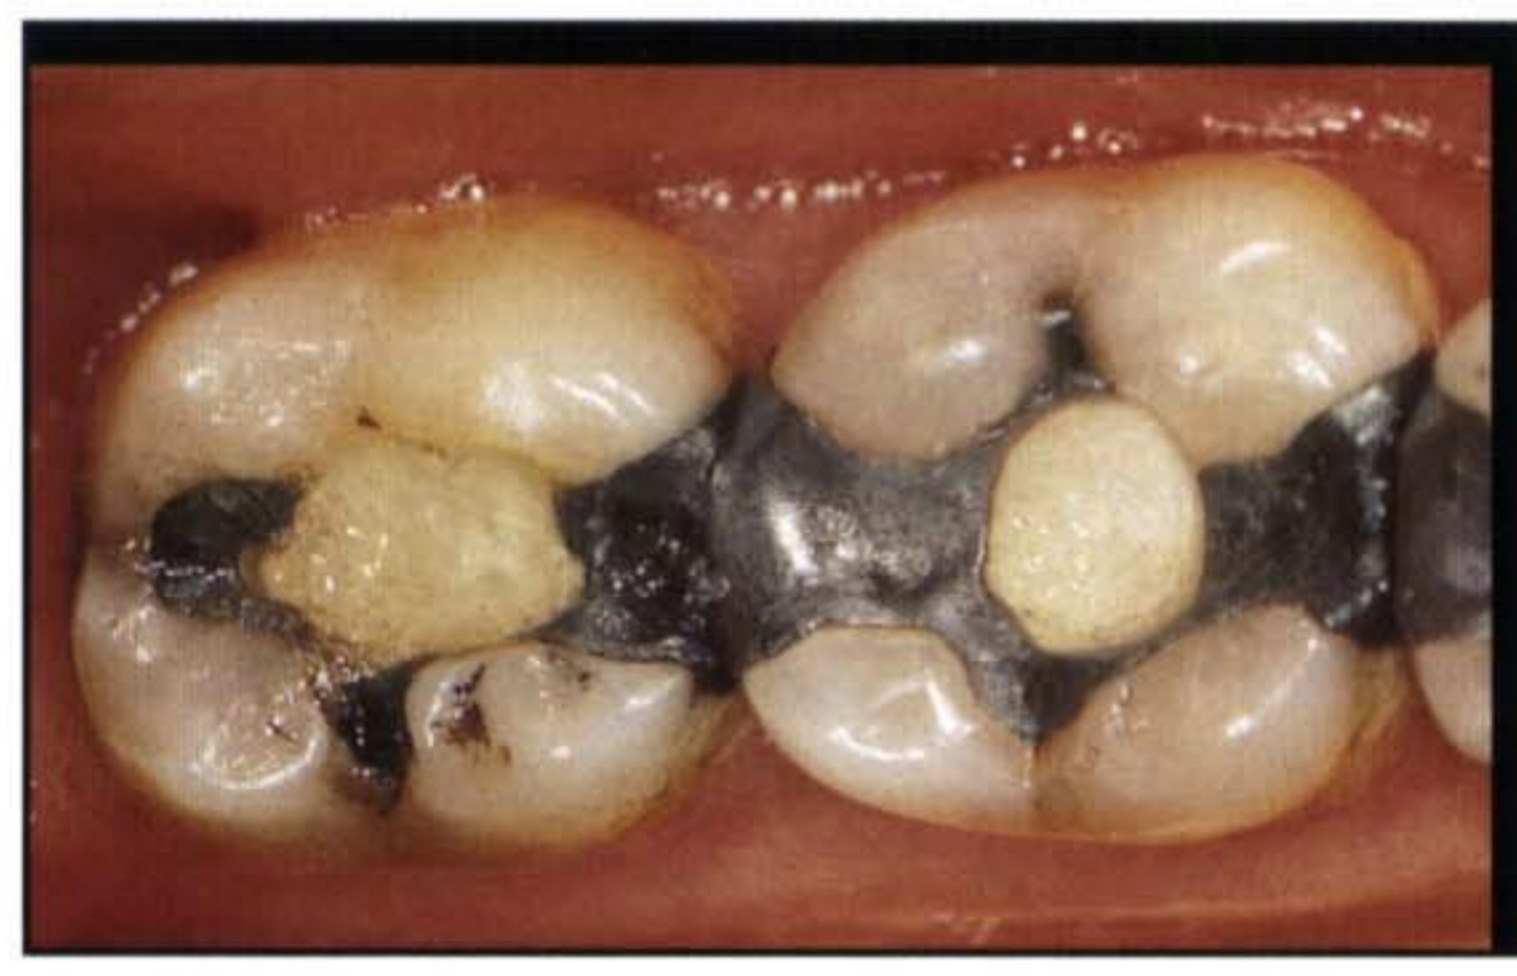
Figure 1. Preoperative view of compromised posterior teeth following the completion of endodontic treatment.

A 47-year-old female patient presented following the successful completion of endodontic treatment that involved teeth #18(37) and #19(36) (Figure 1). An extensive clinical evaluation revealed that no thermal or occlusally advanced symptoms were evident, and radiographic analysis demonstrated no obvious signs of pulpal pathology. The patient's medical history, general health, and periodontal condition were all within normal parameters. Despite undergoing a dental emergency in which teeth #18(37) and #19(36) experienced an acute flare-up of pulpitis, the patient elected not to restore adjacent tooth #20(35). Based on these criteria, a decision as to the optimal method of treatment had to be rendered by the clinician.

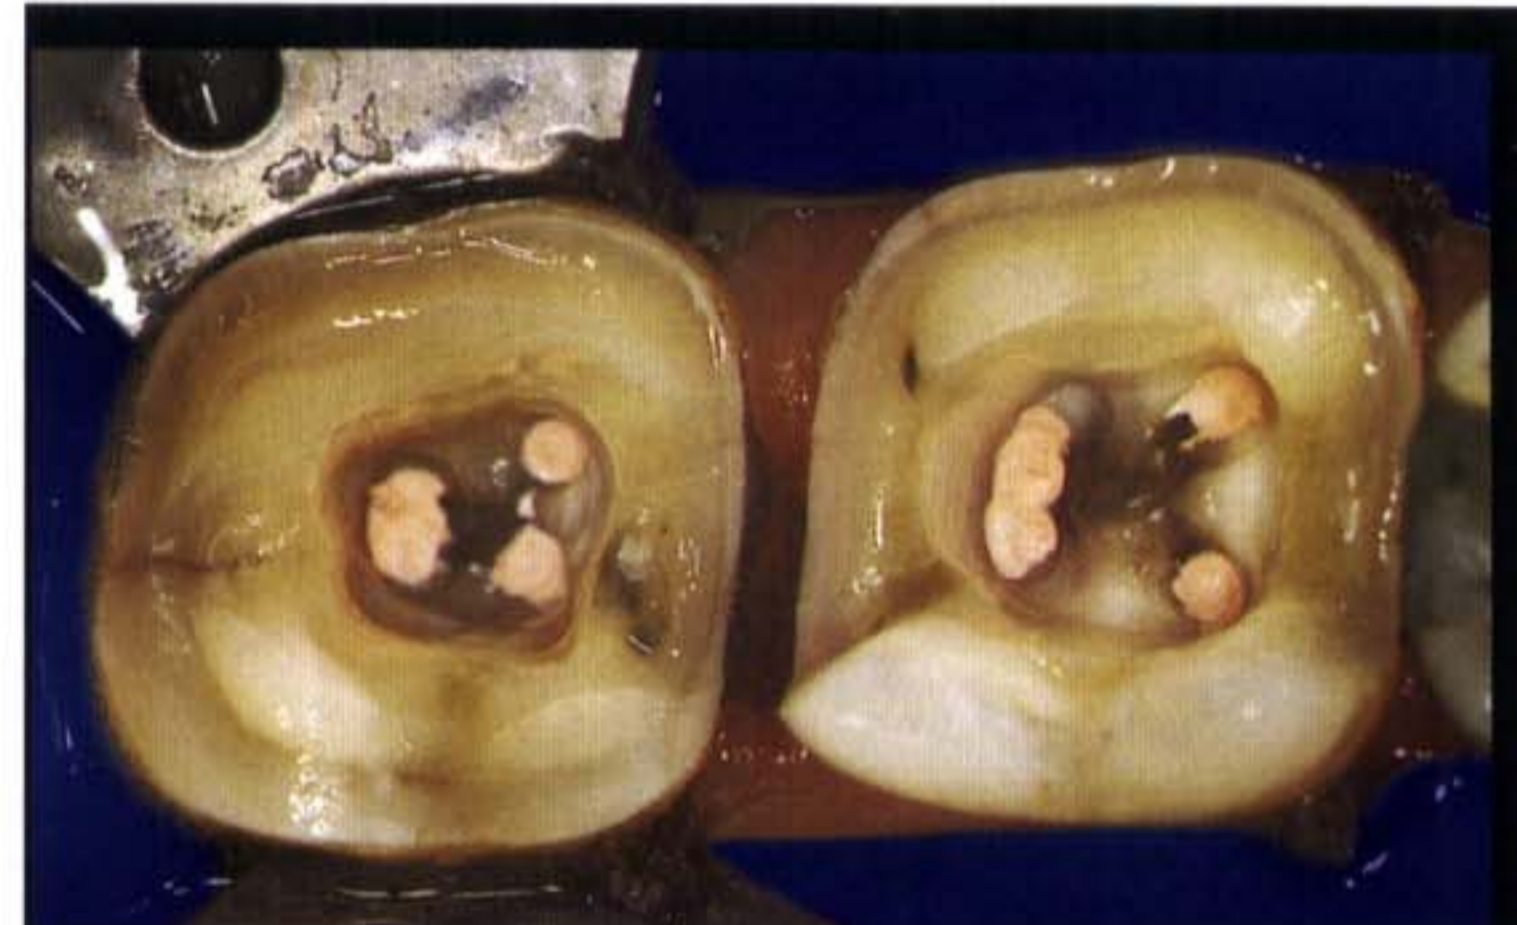
Figure 2. Due to the leakage and wedging effect of the amalgam restorations, a preparation design was required that was more aggressive than originally anticipated.

Once the patient was anesthetized and shade taking was accomplished, intraoral camera prints and color photographs were obtained. A detailed color prescription was developed, a rubber dam was placed to facilitate moisture control, and the failing amalgam restorations and provisional materials were subsequently removed under copious irrigation. Caries detection material (Seek, Ultradent Products, South Jordan, UT) was applied and the remaining carious tooth structure was removed. Large horizontal cracks were evident on the buccal and lingual aspects of tooth #18(37) and the buccal aspect of tooth #19(36). While the obvious leakage and wedging effect of the restorations necessitated an aggressive preparation, the resulting dimensions were conservative in comparison to those required for traditional full-coverage crown restorations (Figures 2 and 3). The preparations for the laboratory-fabricated composite resin restorations exhibited a minimum depth of 1.5 mm in the fissure area and a minimum isthmus width of 1.5 mm. The axial walls of the proximal box area were exposed with a cavosurface angle of approximately 60 to 80 degrees. The final impressions were made with a polyvinylsiloxane impression material (Half Time, Discus Dental, Culver City, CA). The preparations were cleansed with a 2% chlorhexidine solution (Consepsis, Ultradent Products, South Jordan, UT) and lightly air dried without desiccation prior to provisionalization with a medium-heavy material (Fermit-N, Ivoclar Vivadent, Amherst, NY) while the definitive restorations were fabricated in the laboratory (Figures 4 and 5).

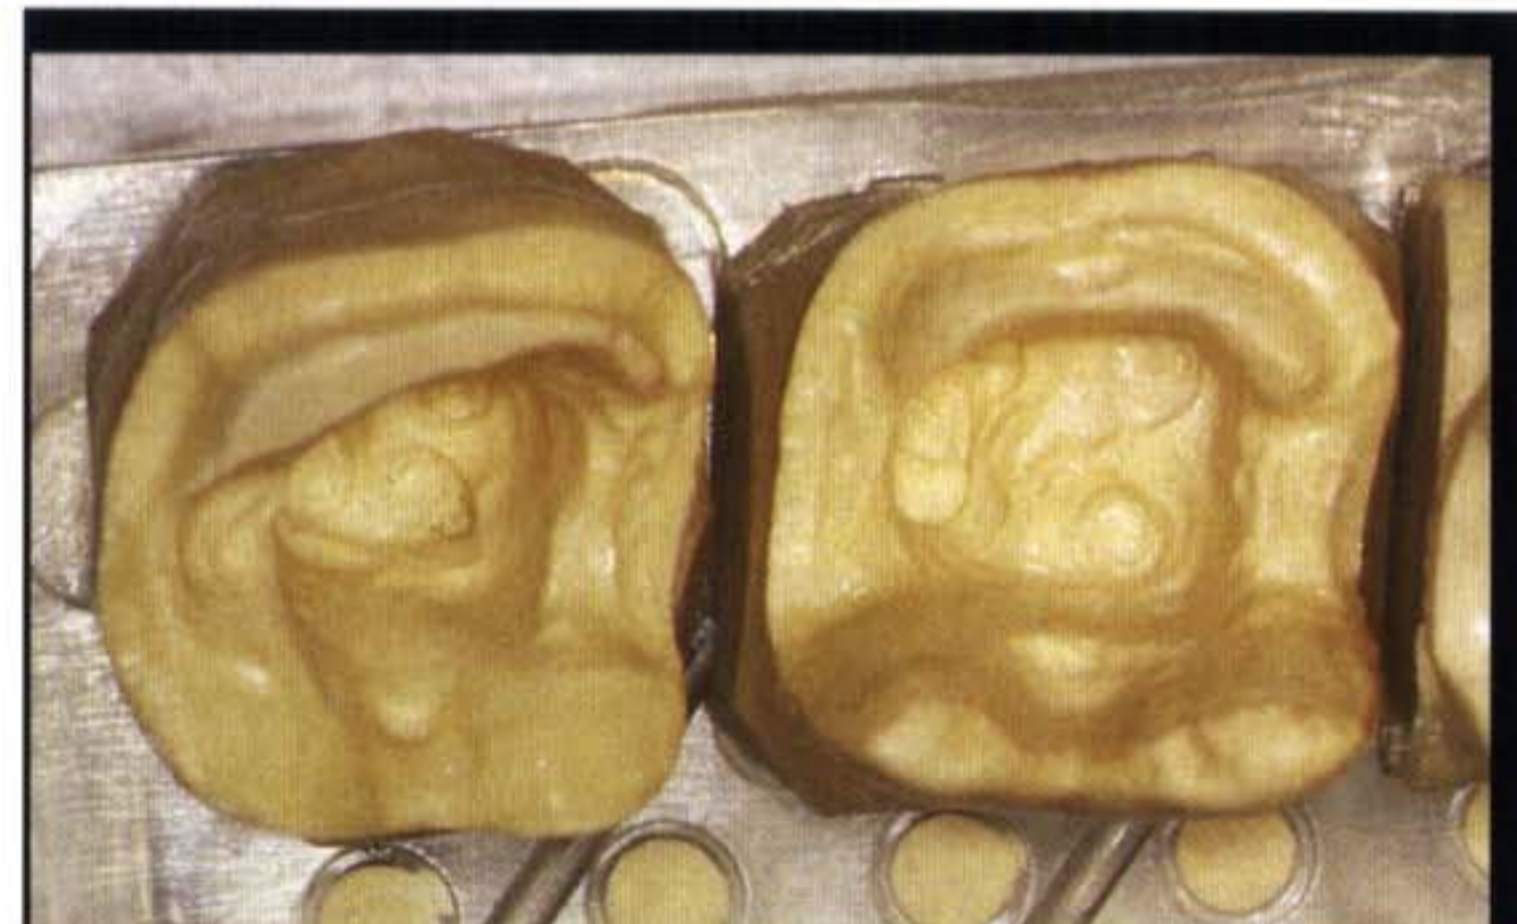
Figure 3. Occlusal view of the master model demonstrates the required preparation design.

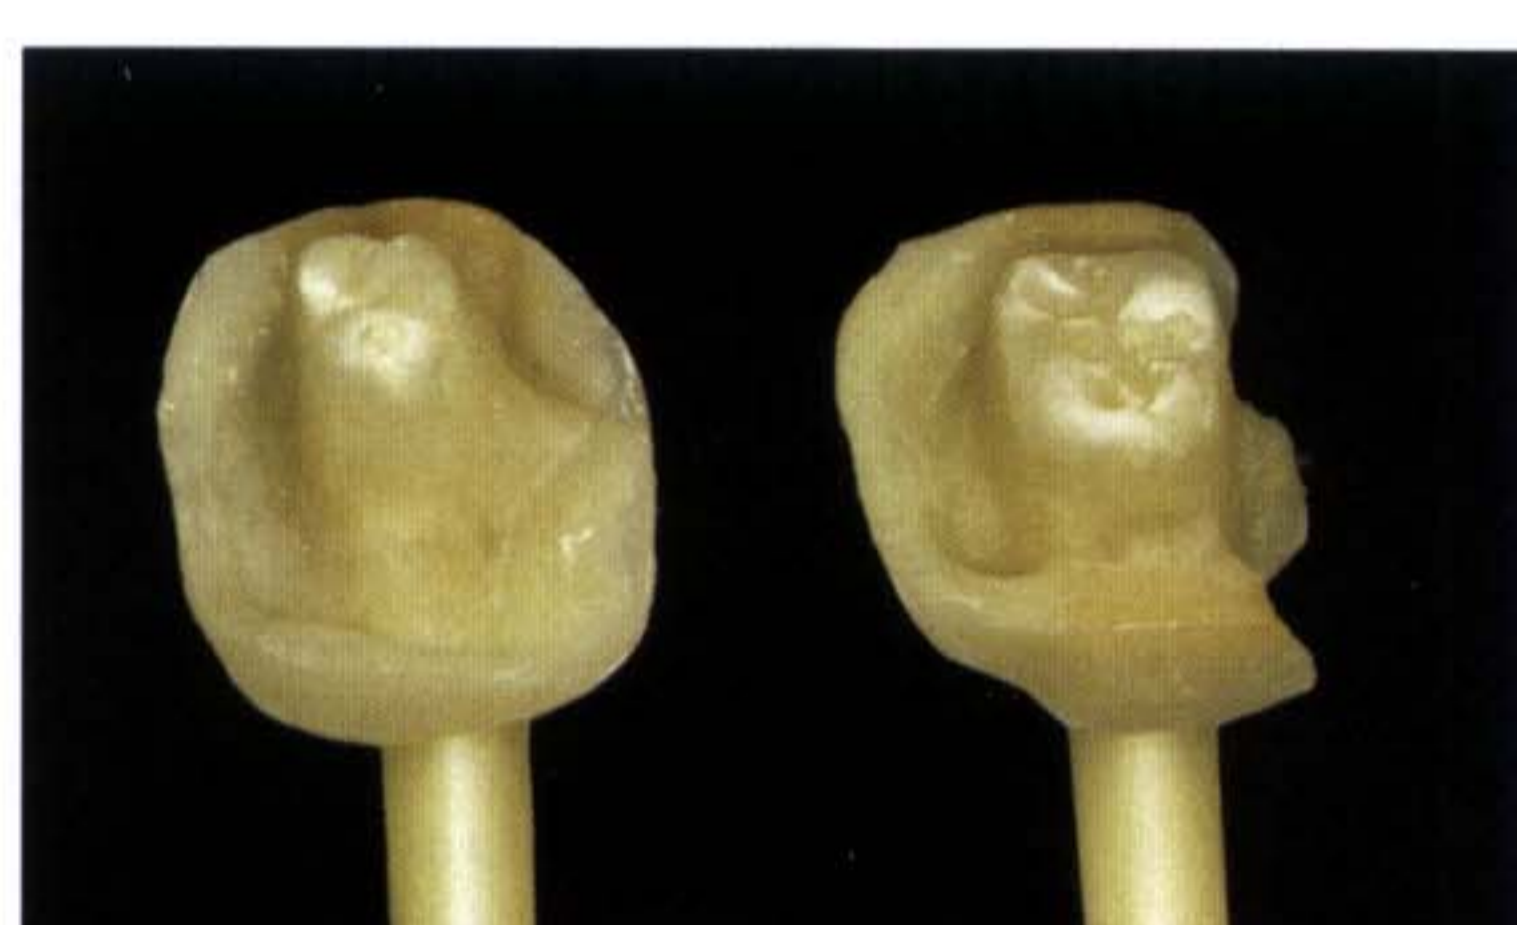
Figure 4. The adhesive single-unit crown and core system has demonstrated increased strength characteristics and the ability to distribute occlusal forces evenly to the roots.
